Technical Service Bulletin

Fastener Sealability

The reason why ASTM D1970 Section 8.9 is not a good representation of air barrier performance in commercial construction

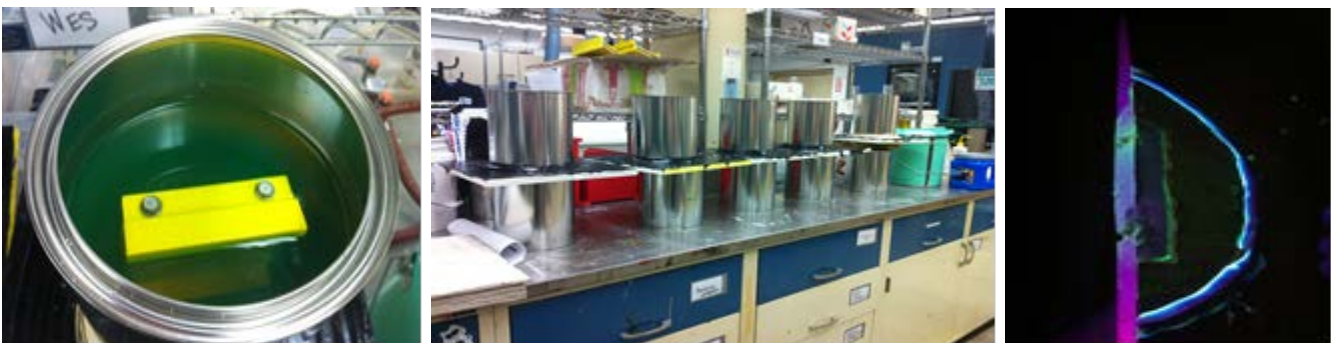
Tremco modified ASTM D1970 Section 8.9 test criteria summation:

1. The test specimen shall be a 12" (30 cm) x 12" (30 cm) sample of the air barrier membrane directly applied to a 12" (30 cm) x 12" (30 cm) substrate determined based on project application.

2. At least two specimens shall be tested.
3. At 73°F (23 °C), install the membrane onto the substrate.
4. If the substrate is a sheathing element like plywood, OSB, or gypsum sheathing. A steel stud will be placed behind the substrate.

5. Drive two fasteners that will be used on the jobsite, 1" to 2" (25 to 51 mm) apart, so that the fastener heads are flush with the surface of the sheet. If the substrate is a sheathing element, ensure that the fastener is installed into the stud framing as would occur on a construction project.

6. Cut the bottom out of a 1 US gal. (4 L) can and center it on the membrane.
7. Apply a bead of silicone sealant completely around the outside rim of the can to bond it to the membrane.

8. Allow 2 hours for the sealant to cure set, and then apply another bead around the inside rim of the can.
9. After waiting 24 hours at ambient temperature, place this assembly atop another 1 US gal (4 L) can which has the lid removed and the bottom intact.

10. Fill the upper can to a depth of 5" (127 mm) with fluorescent traced deionized or distilled water. Place the entire assembly in a refrigeration unit maintained at 40°F (5°C) for a period of 72 hours.

11. Disassemble and note any water located.
12. Observe and report whether or not water is found in the bottom can, on the nail shanks, on the underside of the plywood, or between the plywood and the underlayment sheet. Report as a failure if water is present in any of these areas, or as a pass if dry.

Tremco feels these modifications to ASTM D1970 Section 8.9 are more indicative of what will occur on actual projects. This is a pretty extreme test as this is simulating 5 inches of hydrostatic head against two penetrations for a period of 72 hours. This would equate to approximately 0.18 psi (1,246 Pascal) of pressure or well over a 90 mph (144 kph) wind driven rain directly to the air barrier membrane. This is much more substantial exposure than the membrane would see during its service life once continuous insulation and the cladding system are in place.

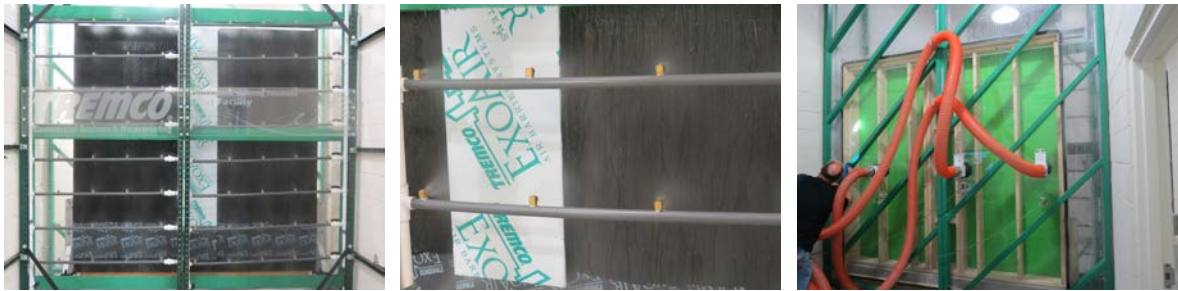
ASTM E331 test criteria summation:

1. The test specimen is typically 8' (2.4 m) x 8' (2.4 m). The substrate is exterior grade glass fiber faced gypsum board mounted onto steel studs 16" (40 cm) on center.
2. The air barrier membrane is installed per the published application instructions.
3. Once the membrane has been installed and is fully cured, fasteners are installed into the substrate, mimicking field installation.
4. An air vacuum is pulled against the substrate at 0.019 psi (137 Pascal) to mimic a 34 mph wind.
5. A water-spray system is initiated, spraying a uniform spray of water at 5.0 US gal/ft²*h (3.4 L/m²*min).
6. Observe and report whether or not water is found on the interior side of any of the fasteners. Report as a failure if water is present in any of these areas, or as a pass if dry.

This test method is even more representative of what may occur on the job site throughout the life of the building. This water exposure is equivalent to 8 inches (203 mm) of rain per hour.
